#	Test	Purpose	Date	Duration	Result	Comments
1	<p>BW6 constant-rate pumping test;</p> <p>Target rate= 5 pgm</p>	<p>1) Estimate large scale equivalent T and S integrated over the open interval of BW6;</p> <p>2) Start a series of sequential cross-hole pumping tests for a “2D” hydraulic tomography among BW 1, 6, 7, 8, and 9.</p>	7/31	<p>Target duration: 48 hours</p> <p>*The target duration is 48 hours, or shorter (if WL in pumping hole falls below the in-well transducer before 48 hours), or longer (if WL drop in pumping hole is slower than expected).</p>	<p>Test was abandoned as the 4-inch submersible pump (rated for 5 gpm) was clogged right after the pump was turned on.</p> <p>After the pump was pulled, we observed sticky clay-like material on and inside the pump.</p>	<div style="display: flex; align-items: flex-start;">

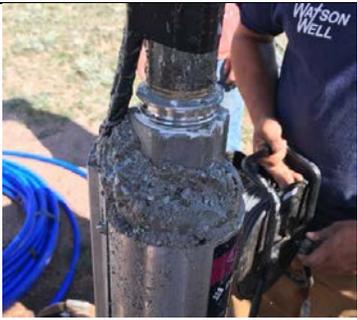
<div style="margin-left: 10px;"> <p>After another borehole camera log, we excluded the possibility of leaking bentonite outside the surface casing. Both red and gray clays were produced during the drilling of BW6 in winter, 2016. The clays are determined to be naturally sourced.</p> <p>One possibility of a source is the clay bed in the adjacent Blair Creek that is connected to the fractures and the clay may have been filling into the fractures over time. The fact that the clay was observed to be accumulated at the bottom of BW6 over a 15 ft interval suggests that clay may be <i>migrating</i> into the open borehole following ambient groundwater flow. Note that BW6 was air-lifted following its drilling in Oct, 2016, and the borehole was well developed with little debris in the bottom. See the Well Test summary table for 2016.</p> <p>Another possibility, as pointed out by Prof. Carrick Eggleston: <i>“From the picture, I see a lot of light-colored stuff that is not like Sherman granite, and some larger nearly black pieces as well. This makes me think of more mafic xenoliths that occur in the granite - there is a major example of this just past Virginia Dale as you go toward Fort Collins on 287, but walking around the Blair area you can find a few of these outcropping. It is not just Sherman and Lincoln granite, but also occasional xenoliths.”</i></p> </div> </div>
